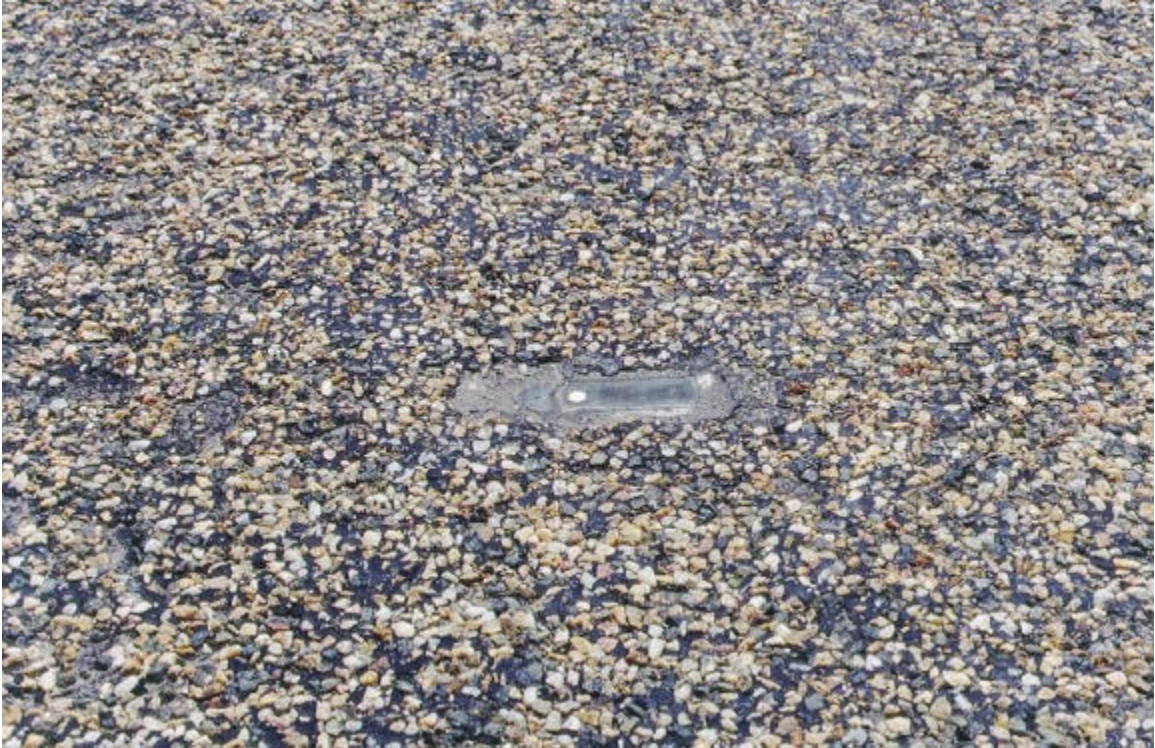
Figure 3.13. Pavement sensor at Skyline RPU showing depression formed by chip sealing (8/11/98).
